Original Research Paper

Monitoring the Rate of Change at Urualla Gully Erosion Site Using GIS and Remote Sensing Methodology

Abstract: Urualla gully erosion was monitored using GIS and remote sensing in Urualla, Ideato North Imo State Nigeria. The objective is to calculate the rate of change of Urualla gully erosion and identify measures to control its growth. The study's data came from primary and secondary sources, such as Google Earth imageries, DEMs, and in situ measurements. Google Earth was used to vectorize and digitize the gully by using a slider tool to get the various years. According to measurements of the Urualla gully, its area has steadily increased. Over time, the gully has shown to be 137,876, 144,897, 164,876, 184,236, 200,000, and 203,065 m², respectively. This shows that gully factors like high runoff, vegetation removal and refuse dumping on drainage channels have been active near the gully site. There is an urgent need for integrated landscape planning due to the loss of land due to gully erosion, urban expansion, industrialization, and further human activities on the land. Various best land low-cost strategies and management techniques can prevent and tackle

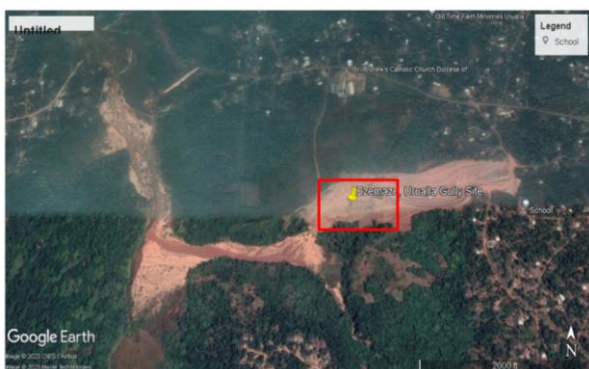
Fig. 5: Google Earth image of Urualla Gully site (Source: Google Earth)

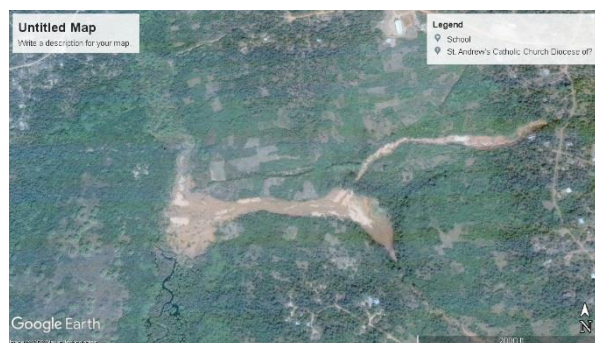
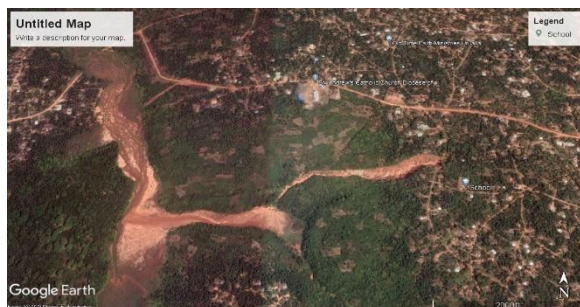
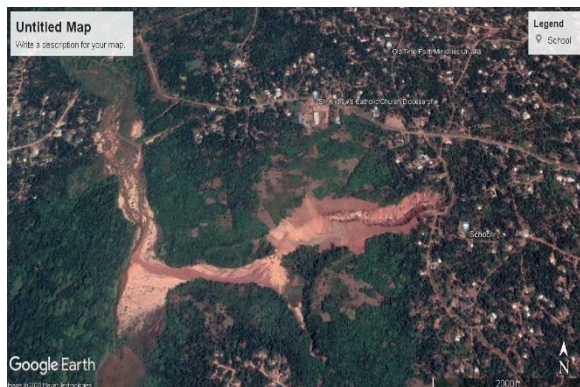
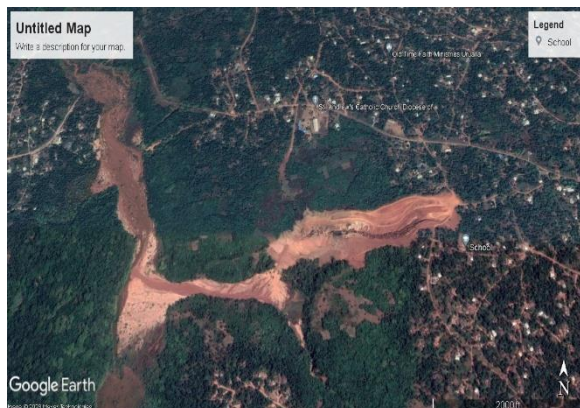
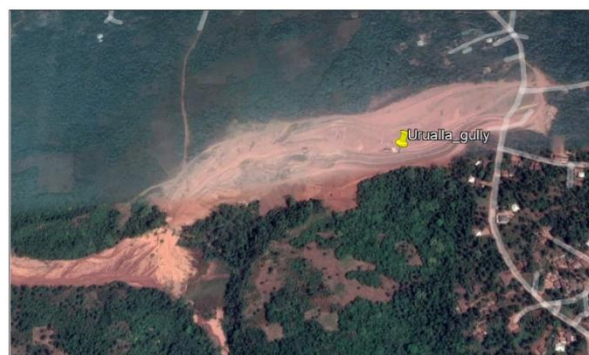
Fig. 6: 2012 Urualla gully image (Source: Google Earth)

Fig. 7: 2014 Urualla gully image (Source: Google Earth)

Fig. 8: 2016 Urualla gully image (Source: Google Earth)

Fig. 9: 2018 Urualla gully image (Source: Google Earth)

Fig. 10: 2020 Urualla gully Image (Source: Google Earth)

Fig. 11: 2022 Urualla Gully Image (Source: Google Earth)

The imageries were acquired from Google Earth and the area of the gully was measured using a ruler tool in the Google Earth. The years of the gully were measured using Time Slider also, a tool in Google Earth.

The imagery Figs. 6-12 was used to ascertain the location of the gully but the study did not go into using it in digitizing it and measuring because it was not clear and trees and forests cover part of the gully site in the imagery.
